Identifying the cause of the growing phenomenon of discoloration and crisscrossing narrow dark lines on solar module surfaces.

Dr. Alan xu, Mr. Swee lim lee Dr. ruijing han

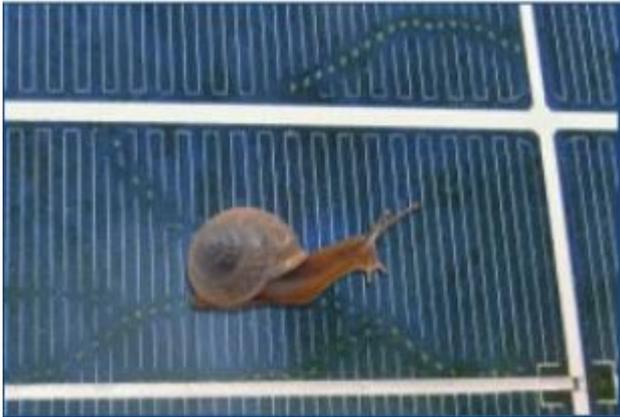
In recent years, the solar industry has been facing a mysterious phenomenon which experts have dubbed snail trail due to its unusual appearance. After a period of time ranging from several months to several years after initial installation, solar modules show some discoloration on the cells, and crisscrossing narrow dark lines about the thickness of a finger begin to appear on the surface of the modules. Snail trail has become a widespread phenomenon, with more than 13 module makers from around the world facing a similar technical obstacle. Although having carried out extensive research, there has not been identification of an exact culprit. However, Canadian Solar, one of the top five module manufacturers in the world, will identify the cause and proper steps to take to treat snail trail.

Based on Canadian Solar's module manufacturing experience, snail trail happens very rarely - affecting very few modules, with the good news being that it does not appear to affect the output wattage. Testing of Canadian Solar's modules with snail trail have been both internally by the Canadian Solar Photovoltaic Testing Laboratory and externally by the Fraunhofer Institute for Solar Energy Systems, a third-party Germany-based research organization, as well as in the field at a power plant. After extensive testing, the output performance reveals no significant drop in wattage, and

the drop exhibited by a very small number of modules was due to cell breakages instead of snail trail. Acceleration aging tests also occurred internally and externally. The reports show the snail trail does not spread after aging, and it does not affect the modules' long-term power output and reliability, echoing many other independent studies.

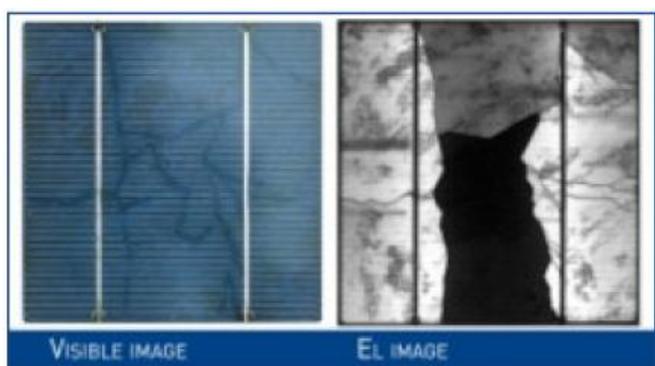
So then, what causes snail trail? In a module, a polymer called ethylene vinyl acetate (EVA) encapsulates the cells. In order to determine the cause, Canadian Solar took the affected solar cell fragments with dark lines on the surface out of the modules and examined them under a high magnification scanning electron microscope - in order to examine them better and view their cross-section, the samples require cutting. The images reveal that the discolored material sits right at the interface between the silver fingers of the cells and the encapsulation polymer. There is no color/metallization structural change in the silver fingers, therefore the conductivity of the modules remained intact. The discolored layer appears on the surface above the metallization, and does not cast a shadow on the cell surface. The results from the examination prove that the crisscrossing dark lines have no direct negative influence on the module power output. Also conducted was an elemental analysis on the discolored regions in both the transverse and cross-sectional directions. Certain transition metal elements and their oxide aggregated at the dark regions comparing to the normal regions.

Canadian Solar's hypothesis of the chemical reactions are the following: the transition metal oxides in the glass frits of the silver paste, the peroxide cross linker, the UV absorber, and the antioxidants are all involved in the chemical reaction. The transition metal oxides help break down the antioxidants in certain environments. The disappearing of antioxidants makes the residual peroxide cross-linker react with the UV absorber, generating dark colored materials. To test the company's hypothesis, first there were changes to the concentration of additives in the EVA, and then there was experimentation of different levels of additives with cells of different types of silver pastes. The results bolstered Canadian Solar's hypothesis. Since metal oxide resides in the silver grid line, the reaction happens only over the grid lines and does not spread over time.

In conclusion, snail trail is an old story happening again in a new age and it does not affect actual solar module performance. Canadian Solar has found evidence that the cause is the addition of certain additives in the glass frits of silver paste and additives in the EVA. After controlling the solar cells, i. e., controlling the silver paste, this phenomenon disappears. To avoid snail trail,

solar module manufacturers need to continue to study the type of silver paste used and materials within the encapsulation polymer.
